American Civil War Fortifications (1)

Coastal brick and stone forts

Series editors Marcus Cowper and Nikolai Bogdanovic

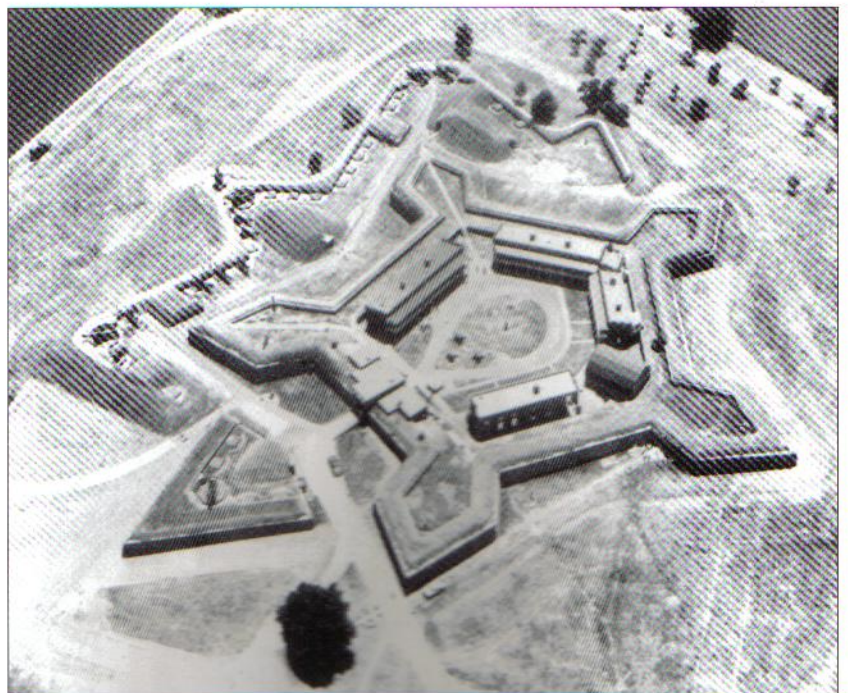
Fort McHenry was first built around 1800 to defend Baltimore Harbor, and became famous in 1813 when it resisted a furious British bombardment. The action inspired the composition of "The Star Spangled Banner." Third System-era outer works augmented the initial five-pointed Second System fortification. (Clyde Hensley Collection)

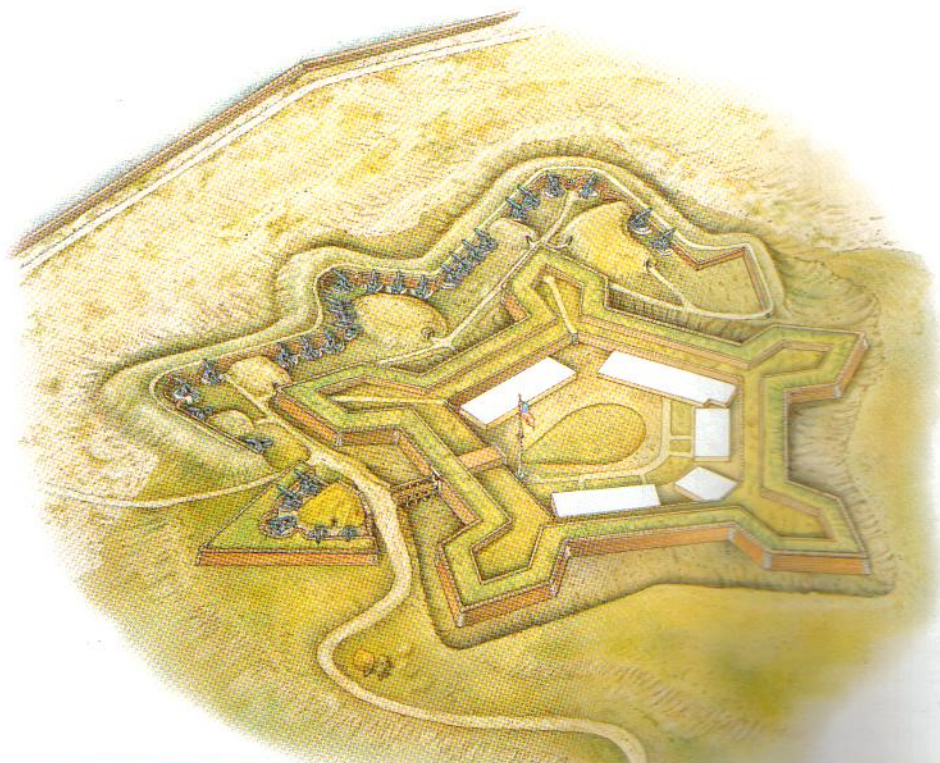
Forts Marion and McHenry

Many forts built before the Third System of fortifications was introduced were converted to conform to the latest notions of coastal defense. Fort Marion (**top**), at St. Augustine, Florida was the oldest example of these refurbished coastal fortifications. Built as the Castillo de San Marcos by the Spanish in 1672, the fort was built along classical Vauban lines, and the modernization as limited to the addition of outer works, and the emplacement of more modern guns. Similarly Fort McHenry (**bottom**) played a major part in the War of 1812, and was then brought up to date in the same manner during the mid-19th century.

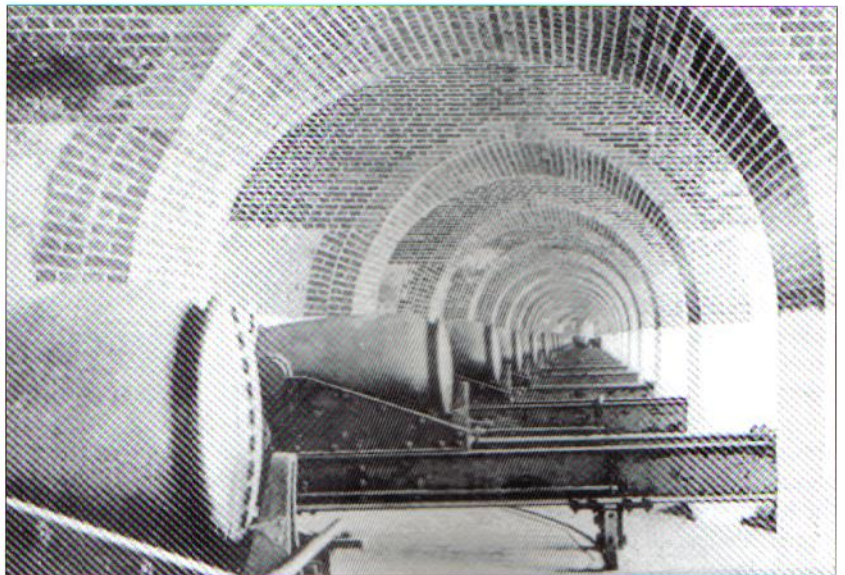
Smoothbore columbiad pieces mounted on iron casemate carriages in the water battery of Fort Monroe, Virginia, photographed shortly after the Civil War. Note the unusual color scheme of the fort, where the lower casemate walls have been painted white. (Estate of Wright Langley)

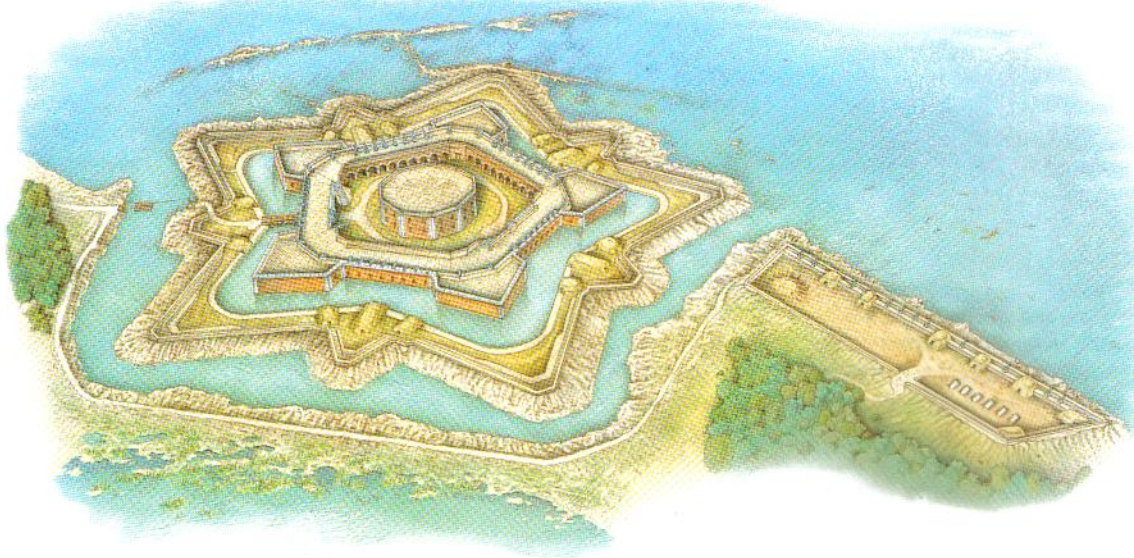
Forts Jackson and McRee

On the shores of the Gulf of Mexico, coastal fortifications had to be built where they were most needed rather than on sites which were ideally suited to the purpose. Fort Jackson (**top**) was built in a swamp on the banks of the Mississippi River, where her casemate batteries combined with those in Fort St. Philip across the river to cover the river approaches to New Orleans. The firepower of the main fort was augmented by the small Water Battery to the south-east, shown on the right of this view. Fort McRee (**bottom**), built to protect Pensacola, Florida was built on sand, one of four brick-built fortifications in the area. Her unusual elliptical design was built to carry 108 guns.

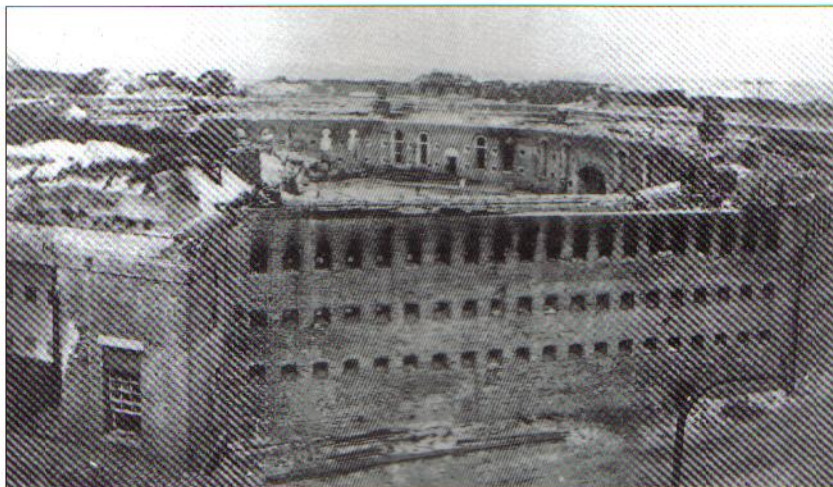
Fort Morgan, Mobile Bay, Alabama, photographed from the nearby lighthouse after her surrender to Union forces in August 1864. The damage inflicted on the fort by the Union fleet was concentrated on the upper works, and the southwestern seaward scarp. (Salamander Archives)

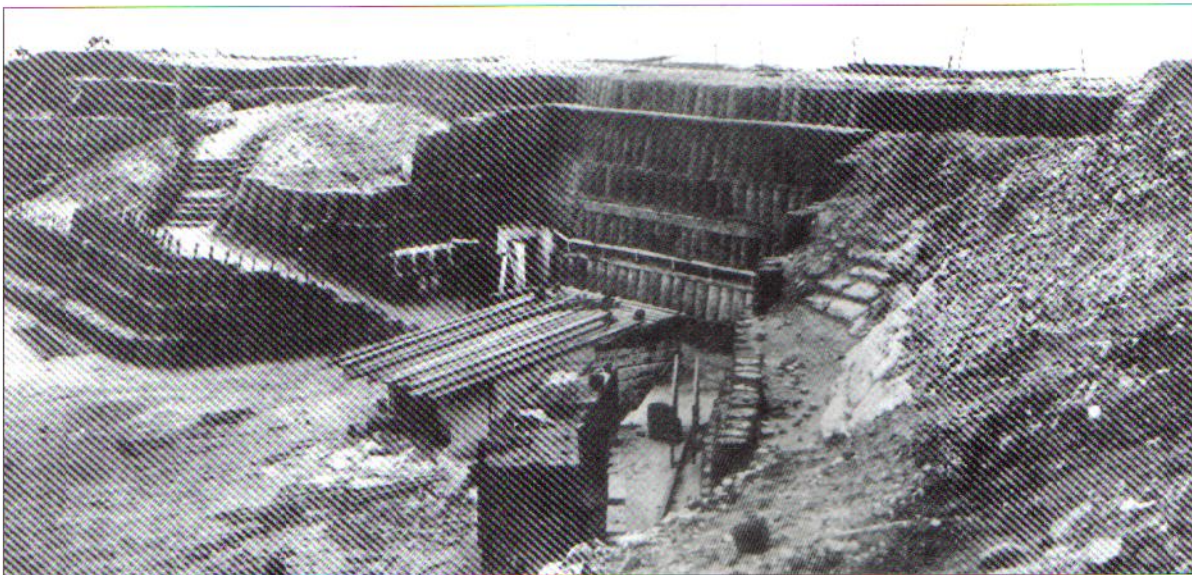
The interior of Fort Sumter after her abandonment in February 1865. When Union troops occupied the fort, they were amazed that it was still a defensible position. The Confederate garrison extensively repaired this casemate. (Stratford Archive)

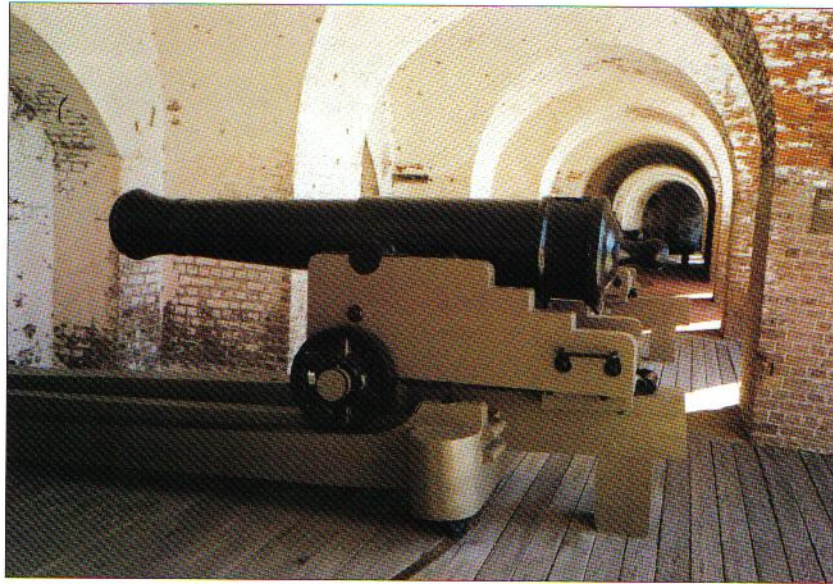
A smoothbore columbiad on a reconstructed wooden casemate carriage. The upper slide carriage is run back as far as the rear chocks of the lower carriage. This was the reloading position of the piece. Note the traversing rails, countersunk into the wooden floor of the casemate. (Author's Photograph)

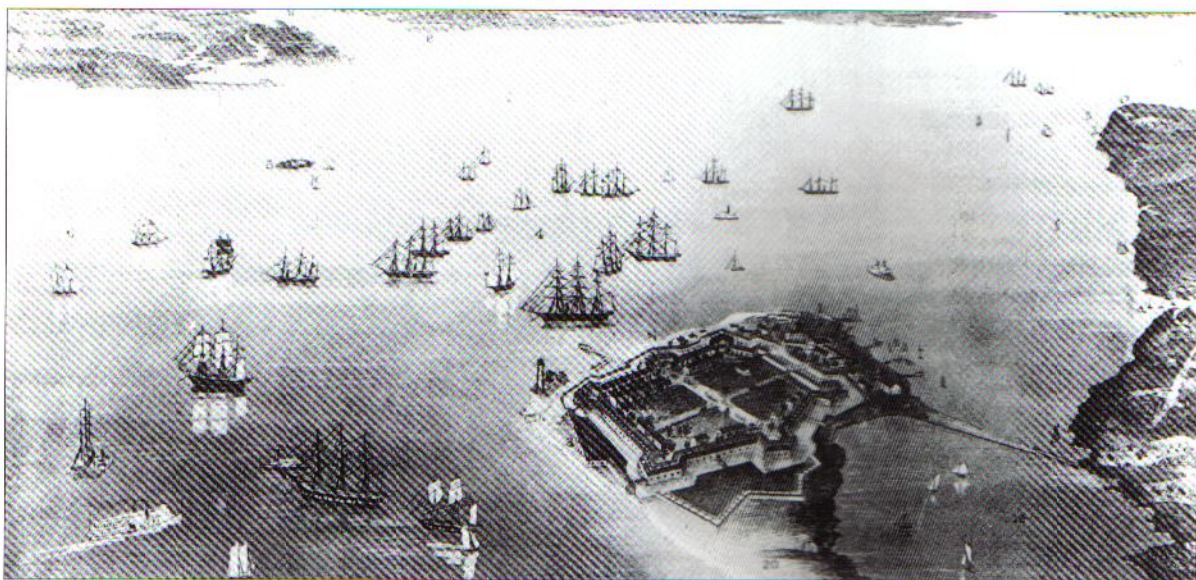
In this general view of Hampton Roads and the mouth of the James River, the dominating position of Fort Monroe in the foreground is clearly evident. Connected to the mainland of Virginia's Peninsula by a small neck of land and a causeway, the fortress acted as a vital bastion for the Union Army within a week's march of Richmond. (Stratford Archive)

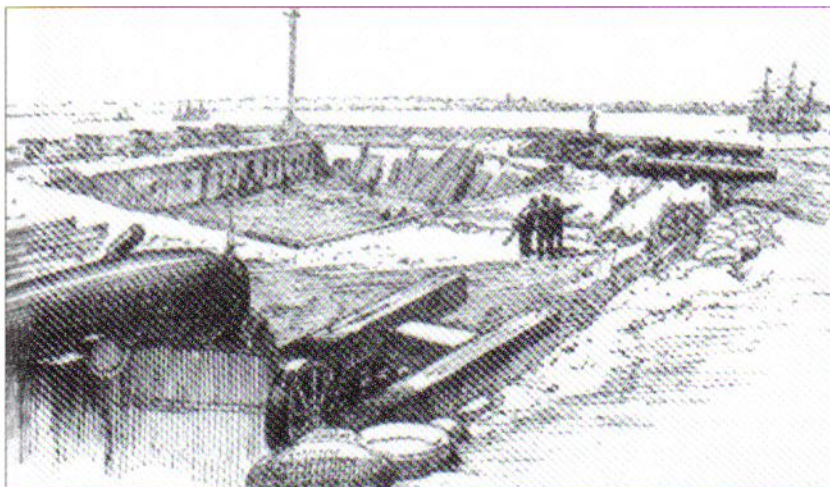
A solitary medium smoothbore gun (probably a 36-pounder) mounted on an *en barbette* carriage remains in place after the scarp protecting the casemates and the rampart and superior slope covering the terreplein of Fort Pulaski were demolished by Union rifled guns. (Stratford Archive)

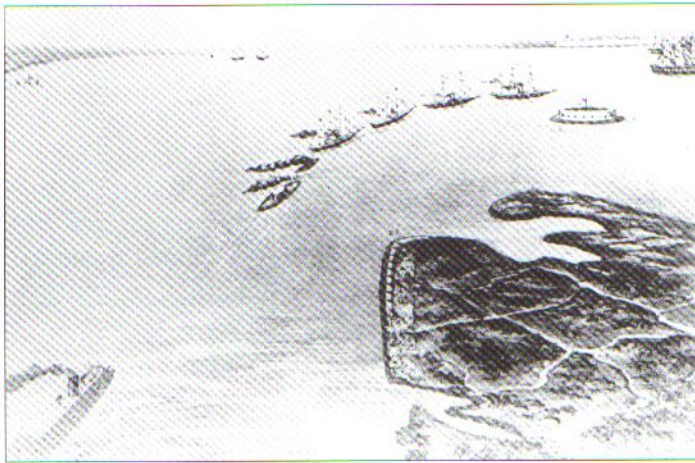
In this contemporary map of the siege of Fort Pulaski, Georgia, the location of the Union batteries on Tybee Island can be seen to the south east of the fort on Cockspur Island. The fort guarding the entrance to the Savannah River was forced to surrender by concentrated fire from Union rifled artillery, firing at a range of just over a mile. (Stratford Archive)

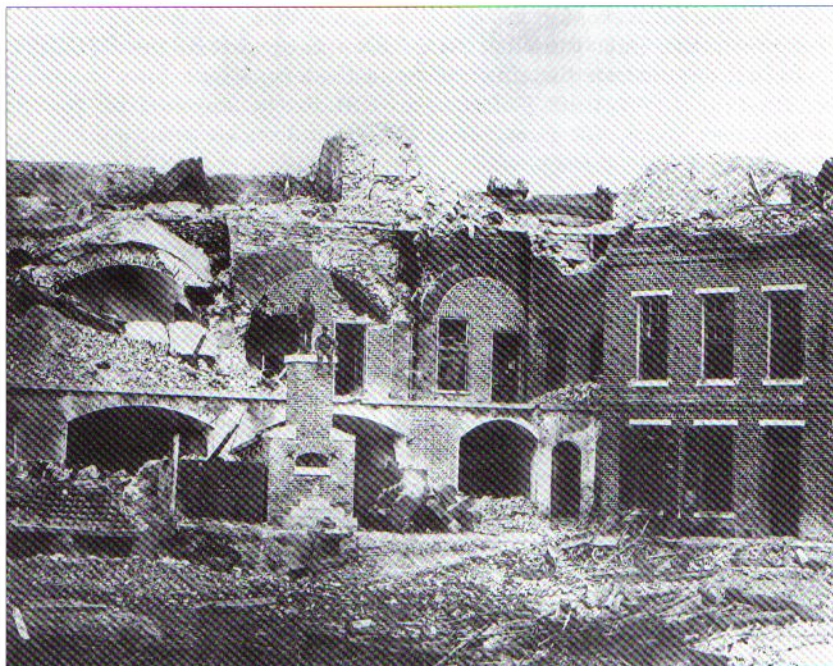
The interior of Fort Sumter photographed in September 1863. The hot-shot furnace appears undamaged, but the northeastern casemate wall and the casemate wall above it have suffered extensive damage. (Clyde Hensley Collection)

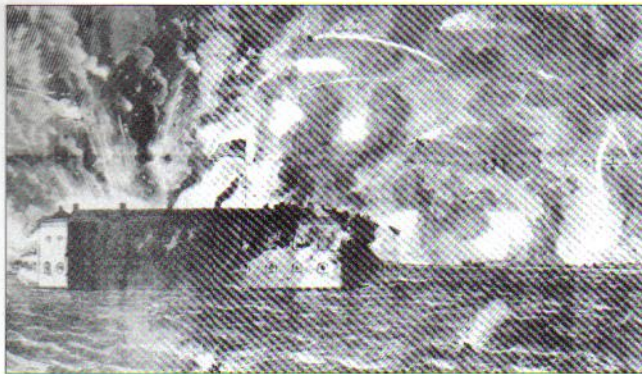
The bombardment of Fort Sumter, April 1861. While explosions are shown ripping apart the barrack blocks, smoke can be seen pouring from the embrasures in the casemates. Defenders claimed that the smoke from the burning buildings was particularly debilitating. (Stratford Archive)

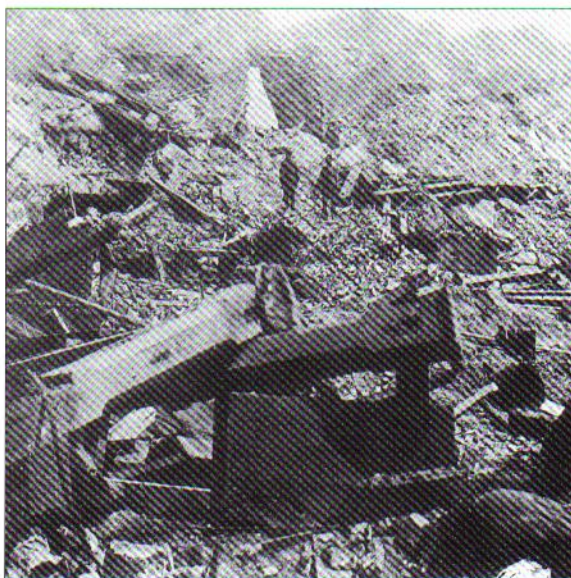
The interior of Fort Sumter photographed in December 1863. The two men in the photograph are standing on the site of the hot-shot furnace. (Clyde Hensley Collection)

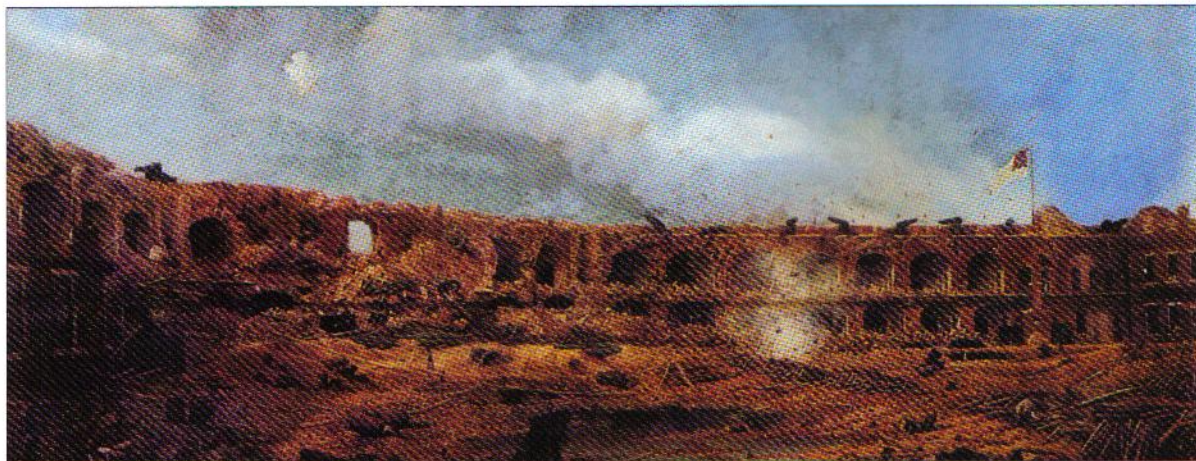
The interior of Fort Sumter in September 1863, from a painting by John R. Key. Based on a contemporary photograph by George S. Cook, both photographer and artist captured the moment when a Union shell hit the northeastern face of the casemate. (Confederate Museum, Charleston, S.C. / Photo from the Clyde Hensley Collection)

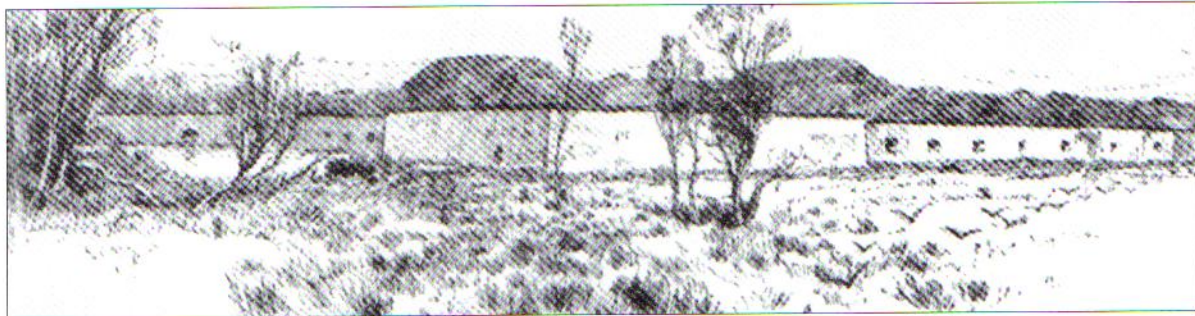
Fort Pulaski

Fort Pulaski, built on the marshy Cockspur Island, Georgia was designed to protect the port of Savannah. The Third System coastal fortification was deemed to be invincible, but advances in ordnance meant that her brick-built structure was vulnerable to accurate long-range fire from rifled guns. On February 19, 1862, Brig-Gen Thomas W. Sherman laid siege to Fort Pulaski, while U.S. Army engineer Captain Quincy A. Gilmore built gun emplacements to the south east of Pulaski from which he could bombard its walls. On April 10 the bombardment began, after the garrison commander had been called upon to surrender. Within hours, Gilmore's rifled guns had breached the south-east scarp of the fort, while mortar shells rained down on the fort's interior. As the outer walls fell away, the rifled shells began penetrating further into the fort, and threatened to hit the magazine. The garrison (opposite) had little choice but to surrender in the afternoon of April 11. This plate shows the area where the damage to the fort was concentrated. Note the earthen outer works beyond the gorge wall on the rear face of the fort.
